**BUREAU OF
RESEARCH, INNOVATION
& INFORMATION TRANSFER**

**NJDOT Corrosion Study on Steel Structural Members
FINAL REPORT**

August 2025

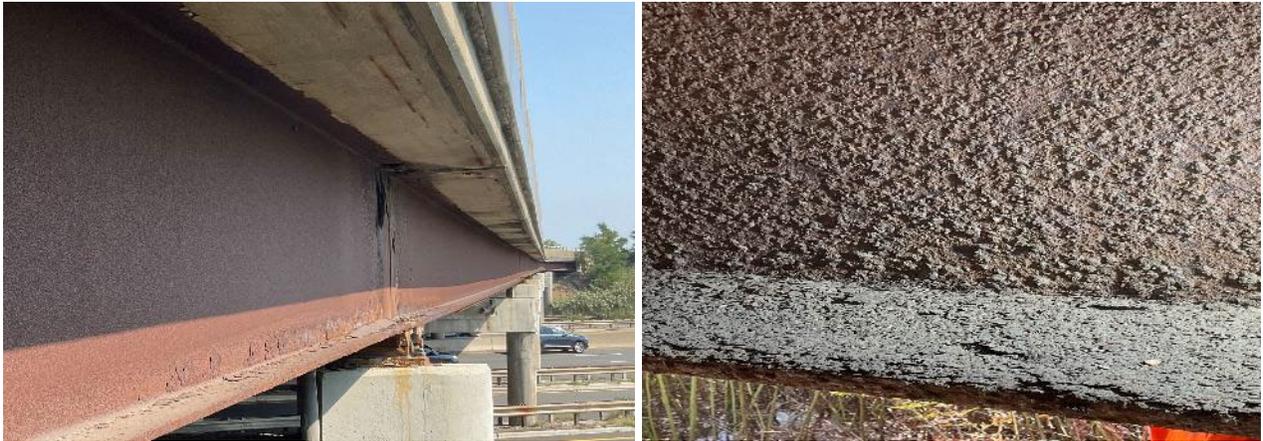
Figure 21. Surveyed WS Bridge in Poor Condition (No. 0725167)

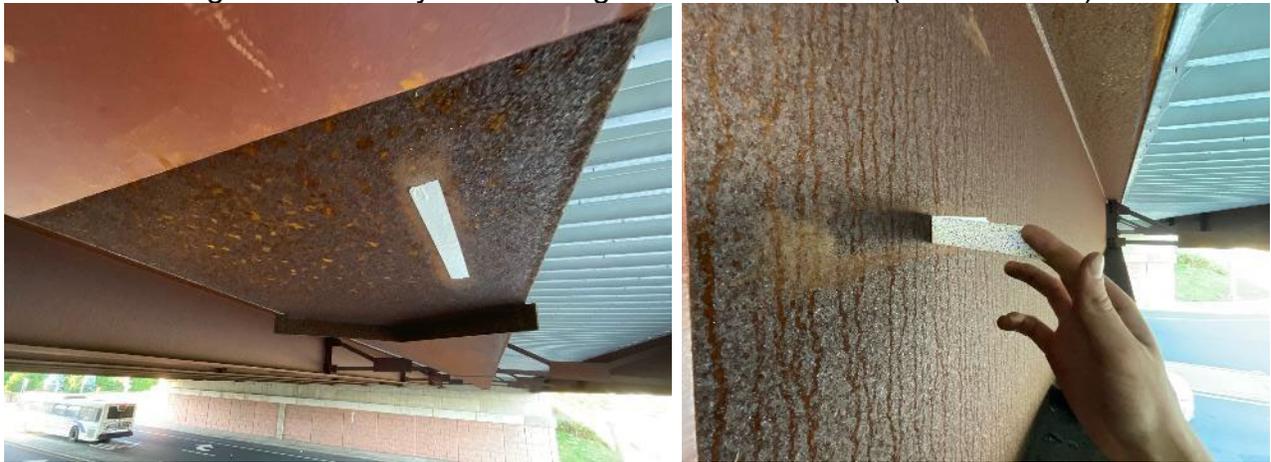
Figure 22. Surveyed WS Bridge in Fair Condition (No. 1202152)
